# Mitigation of Dirty Electricity from Solar Inverters

## Capacitive Parallel Filters Don't Do the Job

# Mitigation of Dirty Electricity from Solar Inverter with DNA Line Filter

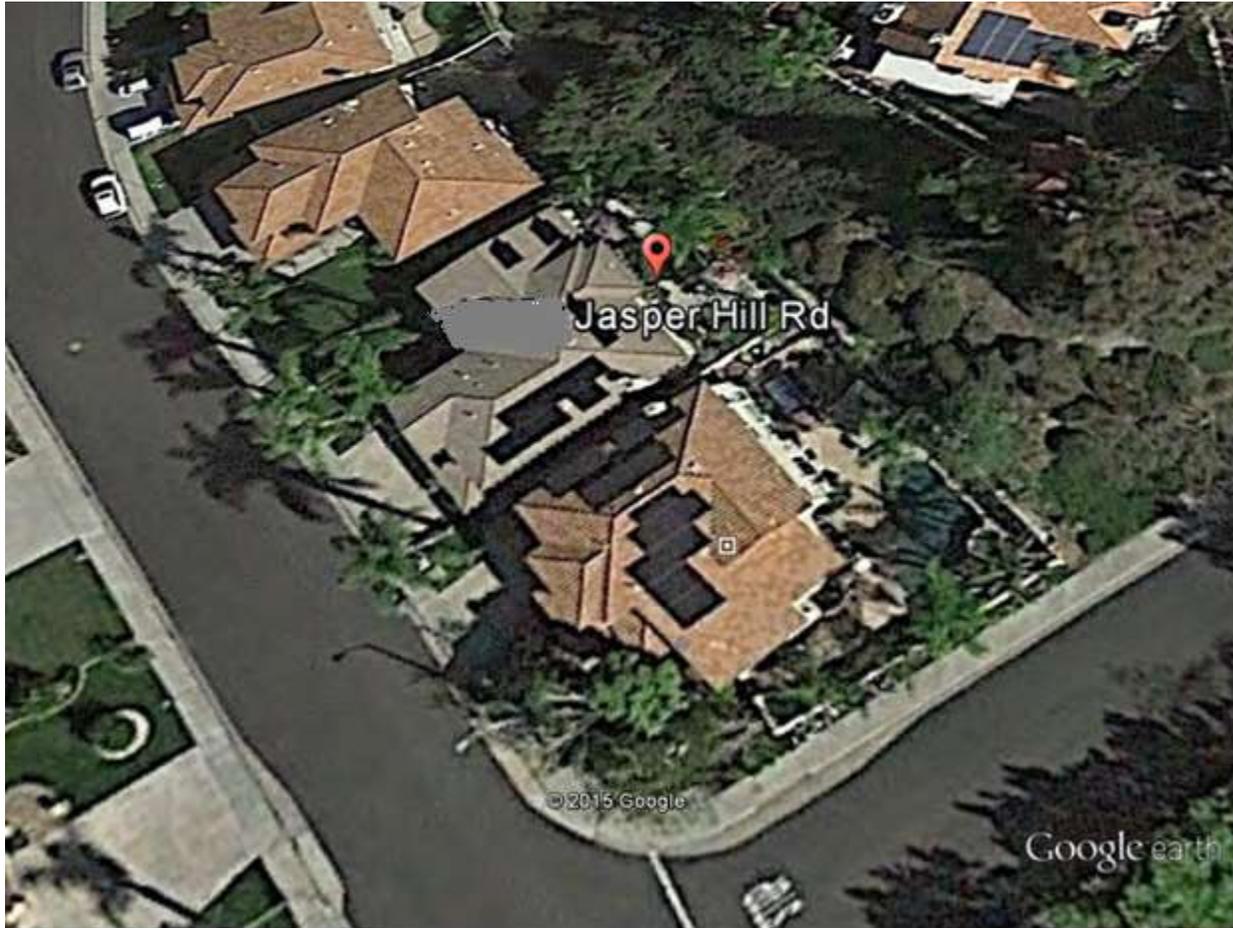
SV roof mounted panels in Trabuco Canyon CA. Main array faces SSW and 3 other arrays WSW.

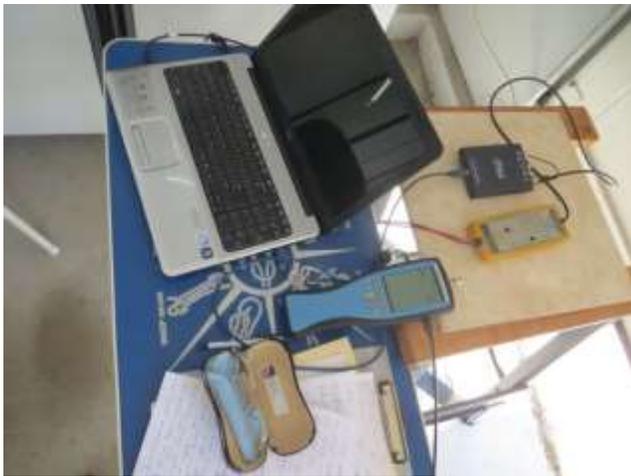
Figure 2 Laptop, picoscope and active differential probe

An instrument list is provided in attachment 1. Instrument set ups are shown in figures 1, 2, 8, 16 & 21.

Instrument setup is shown in figures 1 & 2. SV Inverter Wave Forms (measured at dedicated receptacle near power panel via active differential probe (volts = blue) to Pico-scope and laptop.

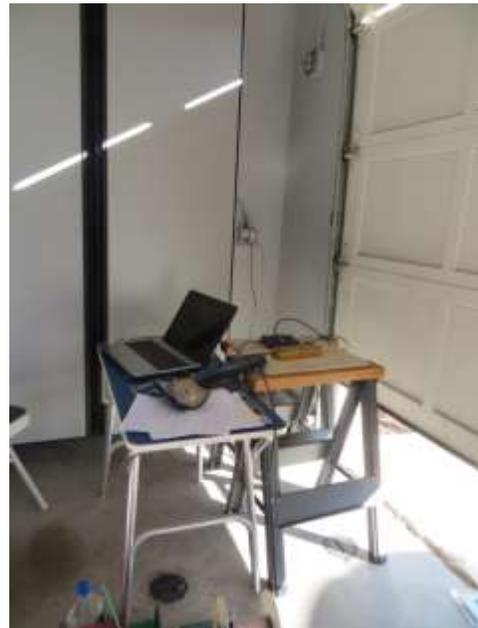
Figure 1 Instruments connected to 120 VAC receptacle

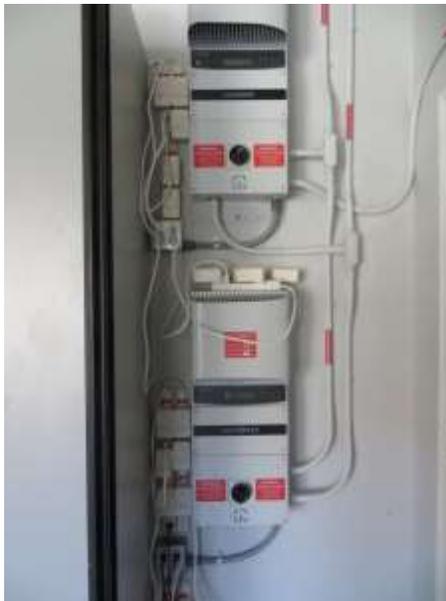
Figure 3 Solar Inverters with filters.

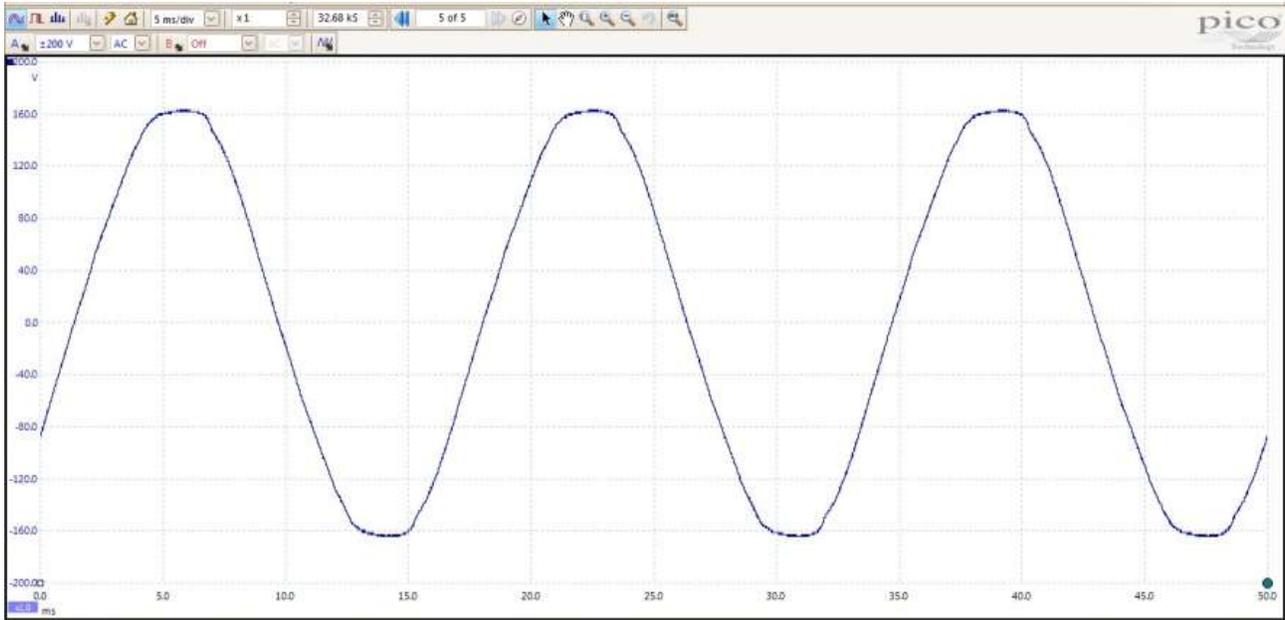
Figure 4 Inverters off. This is the typical waveform of 120 VAC from the grid.

The oscilloscope voltage waveform, figure 4, measured at the power panel receptacle location, with solar inverters stopped, appears as a sine wave, which is the expected form. When the solar inverters are running, the waveform appears as a sinusoidal saw tooth, figure 5. (Note: this waveform is abnormal and indicates that one of the inverters is malfunctioning, e.g., the voltage output of an inverter is required to be a sinusoidal form that replicates the grid per IEEE-519.) With the 19 Stetzer filters added to receptacles located at the solar inverters, the waveform compresses on the top side, still resembling a sinusoidal saw tooth, figure 6. It is easy to conclude that the Stetzer filters do not provide appropriate attenuation for these solar inverters.

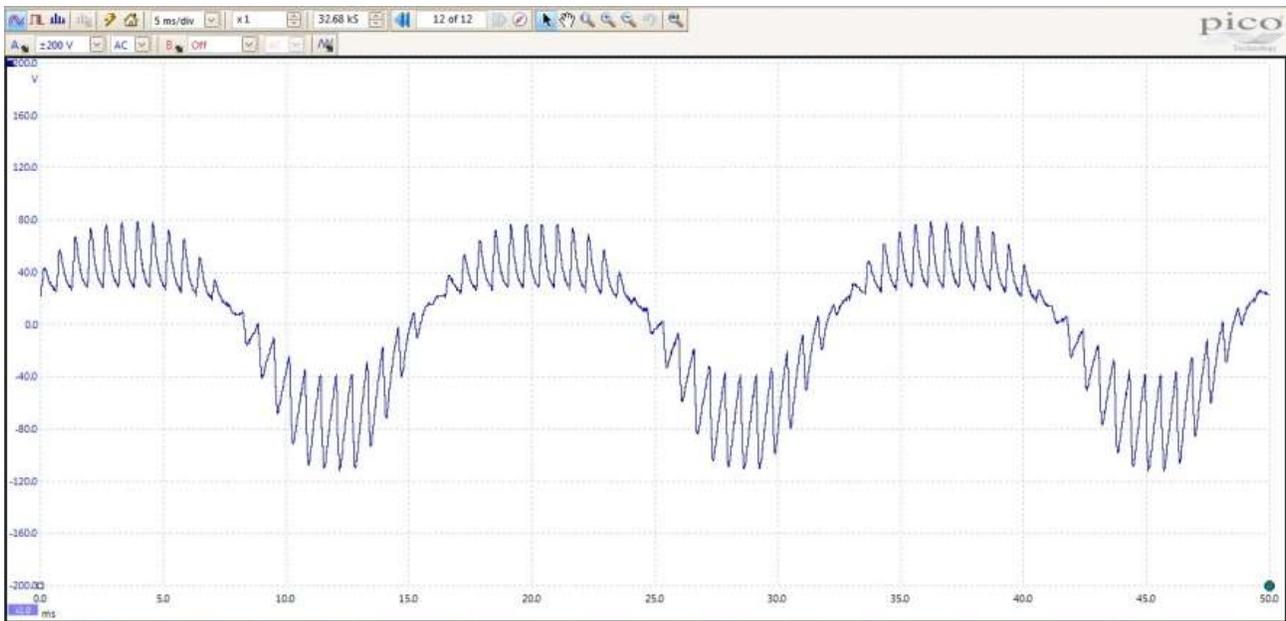
Figure 5 Inverters on. One inverter has a malfunction.

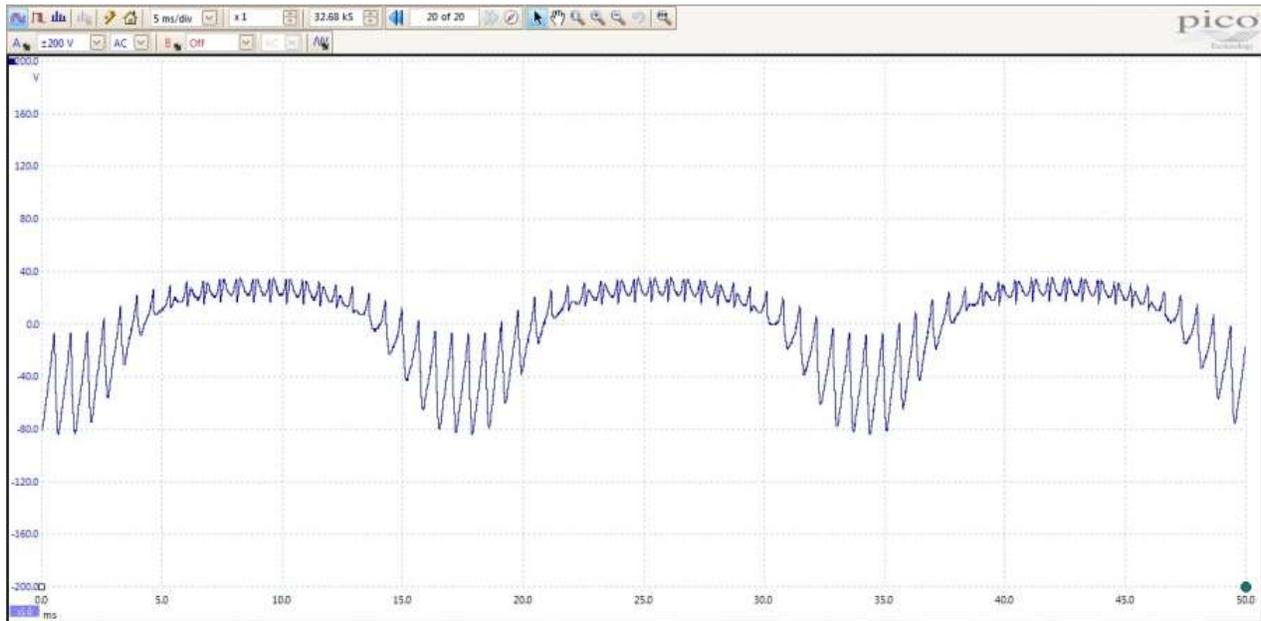
Figure 6 Inverters on with 19 Stetzer filters at inverters, the distorted waveform is not corrected.

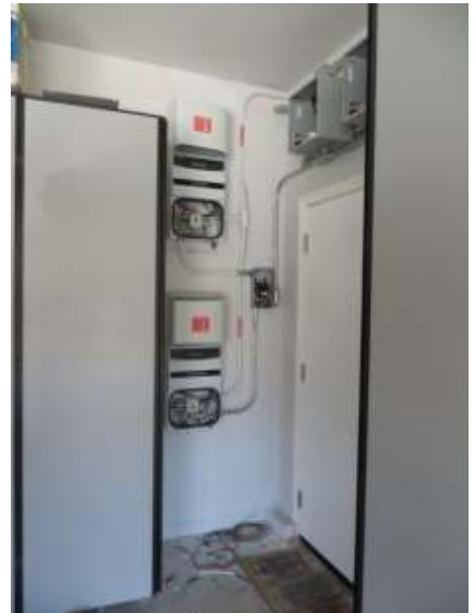
Figure 7 Inverter Sub-panel and DNA Filters

DNA line filters were installed between the new subpanel and the solar disconnect switch located near the power panel outside the garage. See figure 7 below.

Oscilloscope voltage and current waveforms were recorded, with one SV inverter operating, before and after the DNA line filter using active differential probe (volts = blue) and clamp-on meter (amps = red) to Pico-scope and laptop. The new subpanel and DNA line filters are shown in figure 7, with the hookup to the DNA line filter in figure 8.

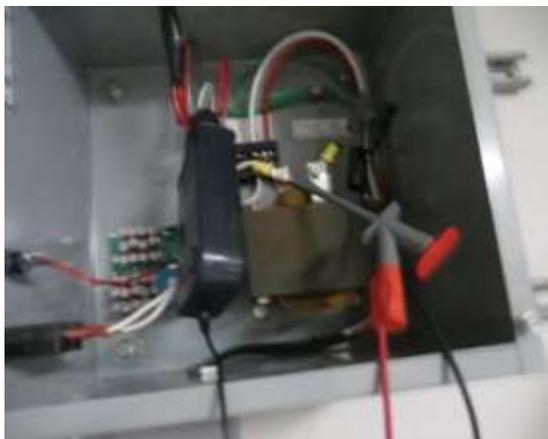
Figure 8 Test Points at DNA Filter.

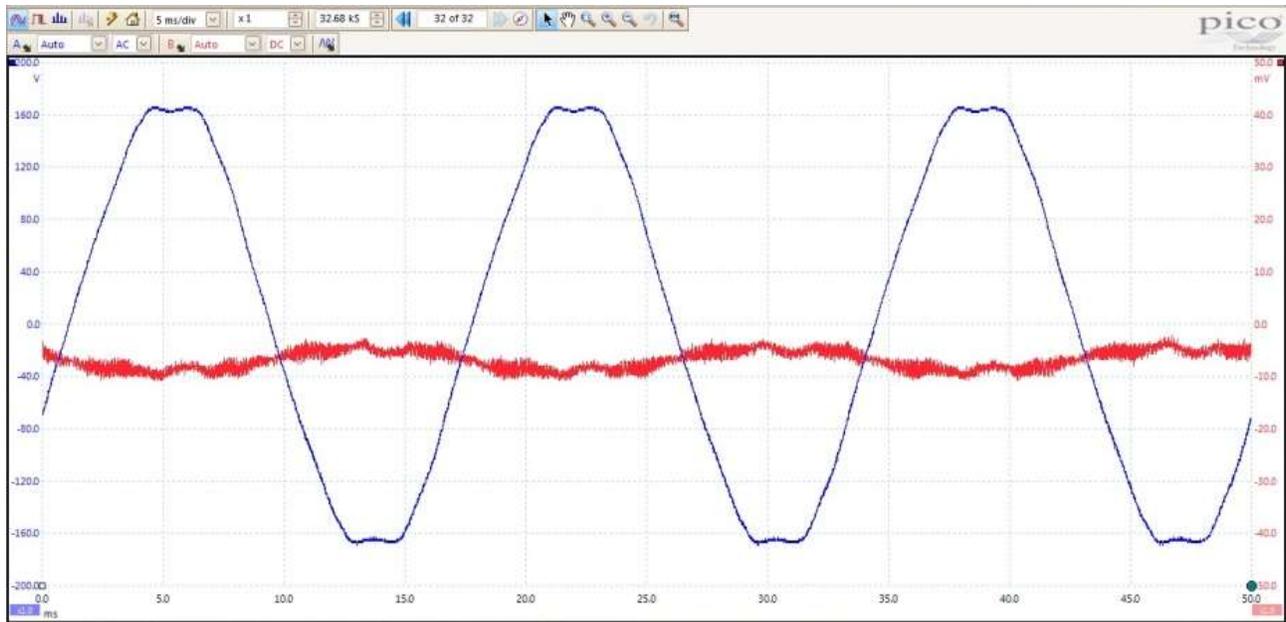
Figure 9 Waveforms from inverter at subpanel, before the DNA line filter.

**4.2.1 Waveforms:** At the inverter subpanel the voltage waveform, figure 9, is sinusoidal in shape with some distortion at the crests. The current waveform is also sinusoidal and carries multiple harmonics (EMI -electromagnetic interference) from the DC to AC conversion.

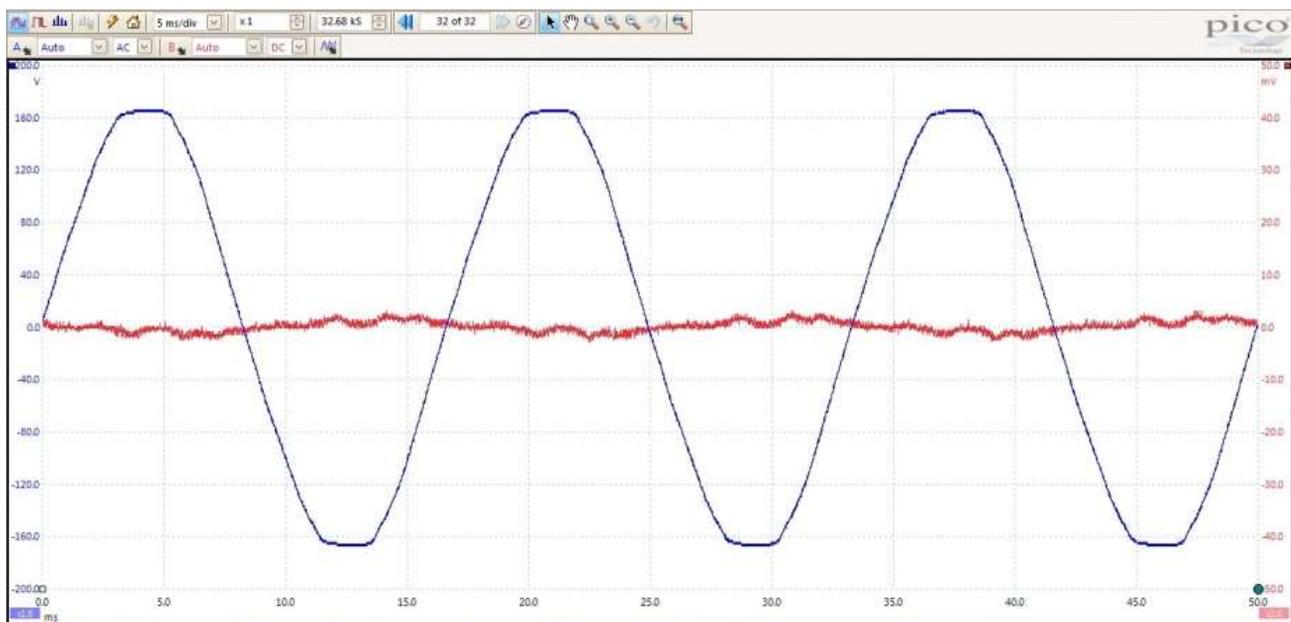
Figure 10 Waveforms from inverter at output of DNA line filter.

At the filter out, the voltage waveform, figure 10, looks just like the waveform recorded at the power panel with inverters off. The current waveform here is much smoother. Proximity of current clamp to incoming cable appears to be affecting current waveform.

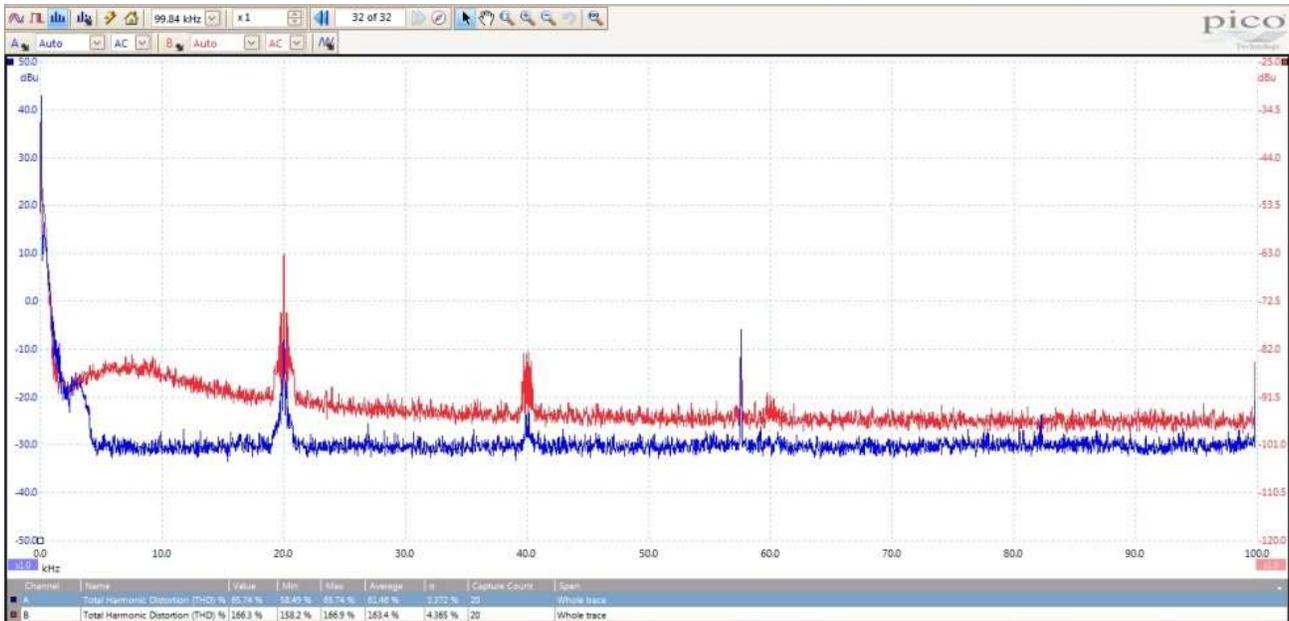
Figure 11 At inverter subpanel before DNA line filter (malfunctioning inverter off).

**4.2.2 Spectrums:** Oscilloscope Spectrums were recorded, with one inverter operating, before and after the DNA line filter using the same equipment. These are in logarithmic scale format so that the higher frequencies are not masked by the 120 VAC. The spectrum at the inverter subpanel, figure 11, shows the characteristic 20 KHz DC to AC conversion frequency and harmonics. These frequencies are gone after the DNA line filter, figure 12.

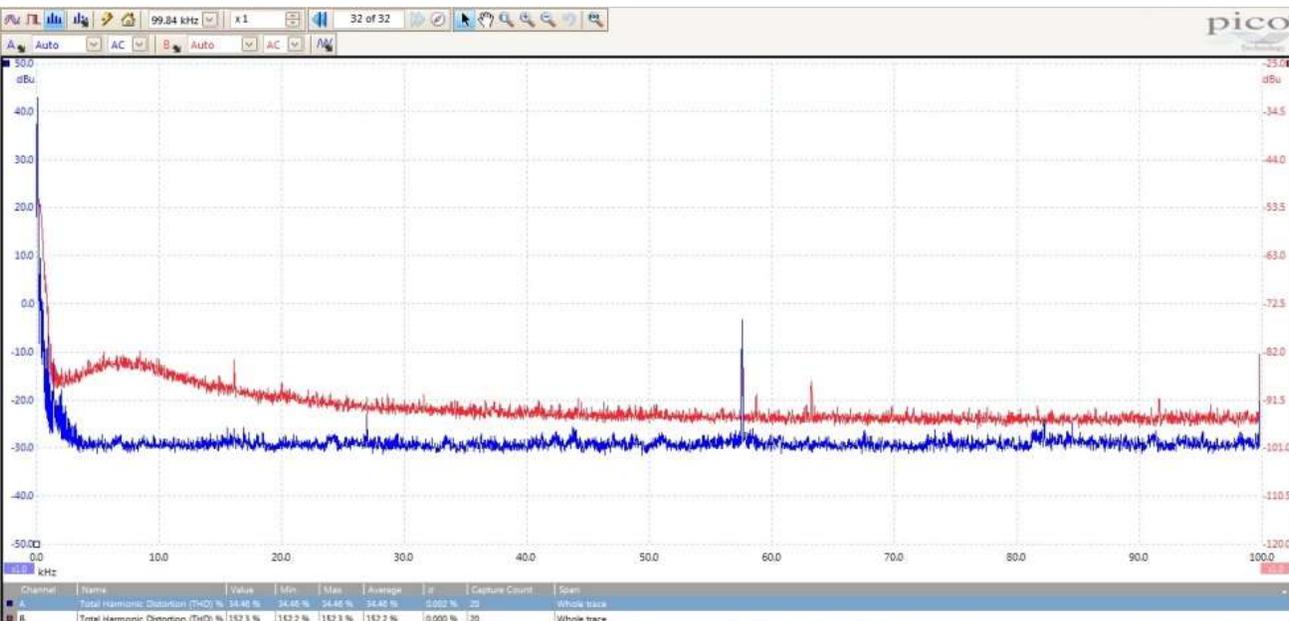
Figure 12 After DNA line filter (malfunctioning inverter off). The 20 KHz and harmonics are gone. The 57 KHz spike is from the laptop.

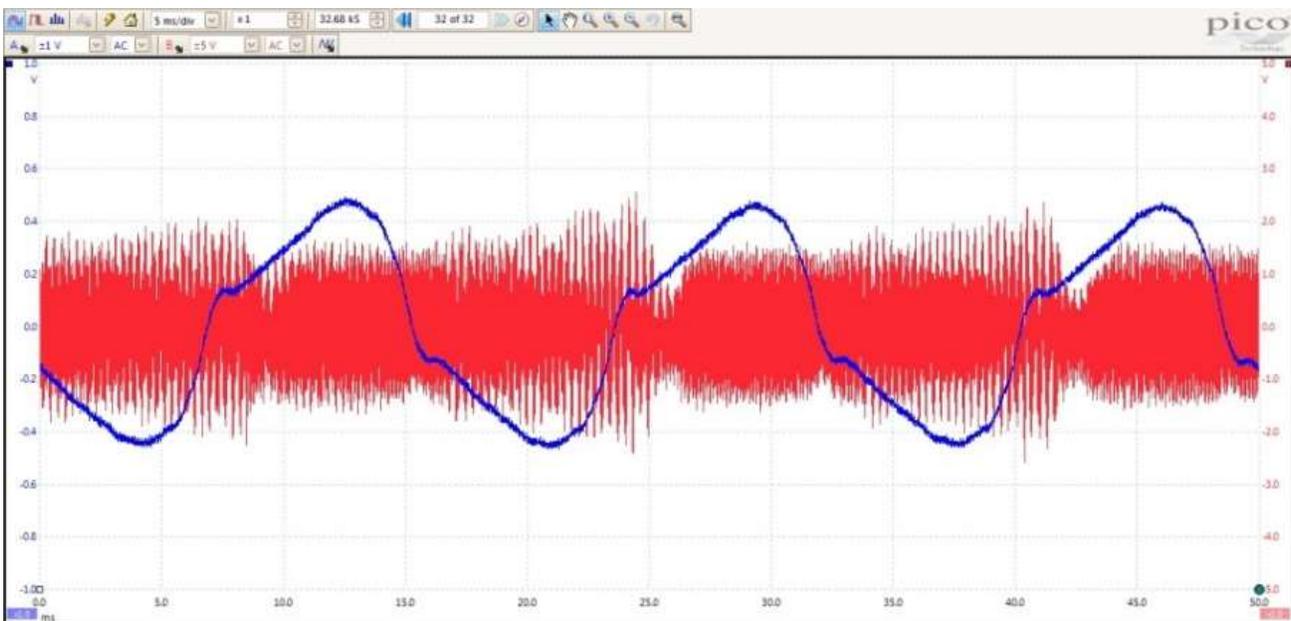
Figure 13 Solar inverters on and all Stetzer filters installed

**5.1 Oscilloscope EMR waveforms** were recorded at a 2<sup>nd</sup> story bed with the inverters running, with and without Stetzer filters in place, and with an inverter running with DNA line filter installed. EMR is the magnetic field and electric field measured on the bed with instrument setup shown in the figures 16 & 21. The magnetic field waveform (blue) is a reflection of the current in the house wiring, figure 13. It is a distorted sine wave characteristic of harmonics and dirty electricity. The voltage waveform (red) is a reflection of voltage EMI and dirty electricity in the house wiring, figure 13. The apparent level of EMI with 21 Stetzer filters in the home and another 19 at the inverters appears to be higher than with no Stetzer filters, figure 14. The magnetic waveform normalizes and the EMI is almost gone with the DNA line filter, figure 15.

Magnetic field (nano tesla (NT)) is the AC output of a Gigahertz ME 3951A meter selected to 50-400 KHz band (blue line) and electrical field (V/M) is the AC output of a ROM Dual Field 1 meter selected to >2KHz (red line) connected to Pico-scope and laptop. The device outputs are not calibrated to the Picoscope.

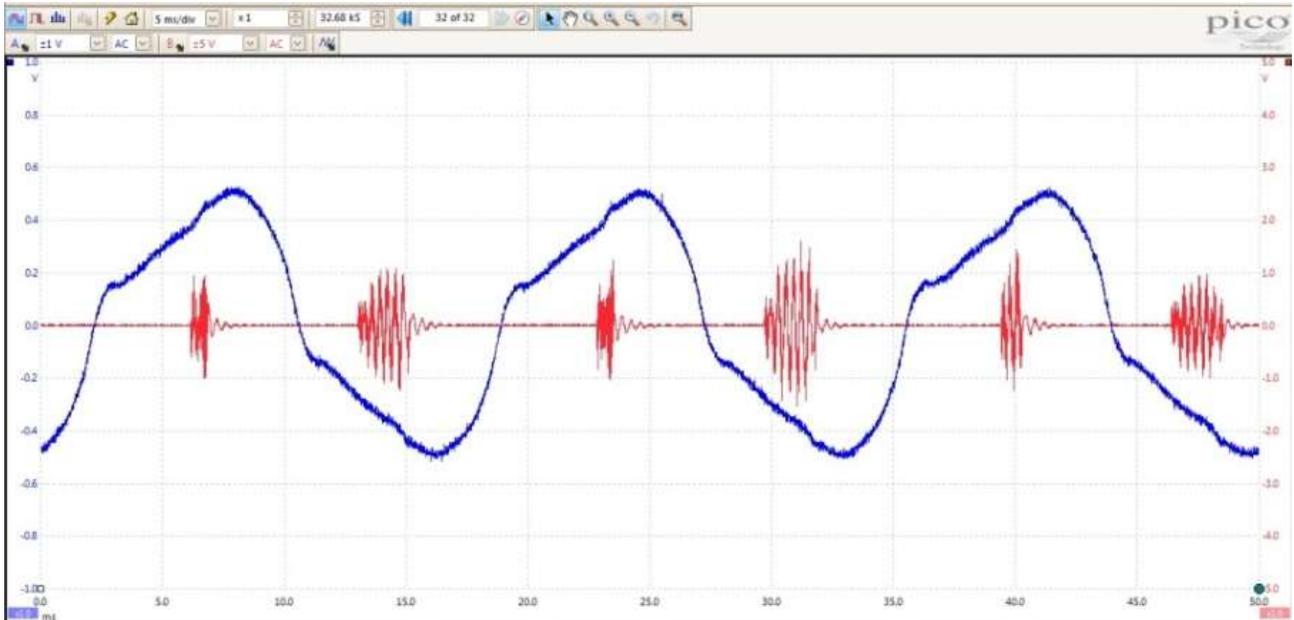
Figure 14 Solar inverters on and all Stetzer filters removed

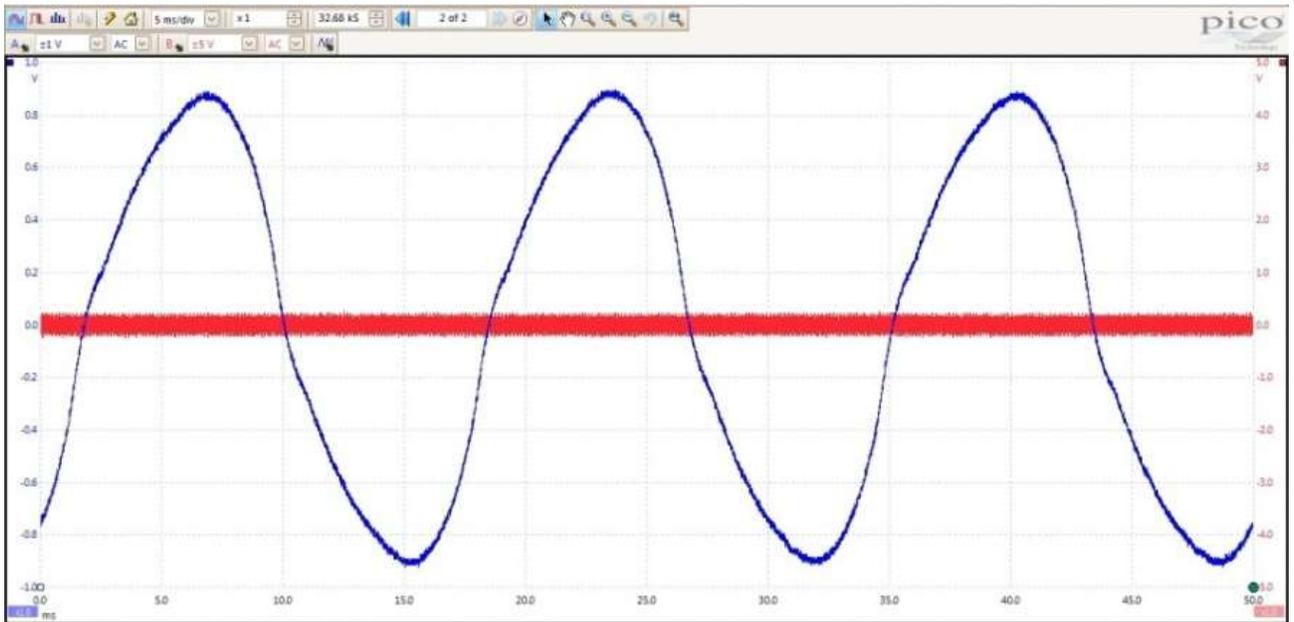
Figure 15 One inverter on with DNA line filter installed

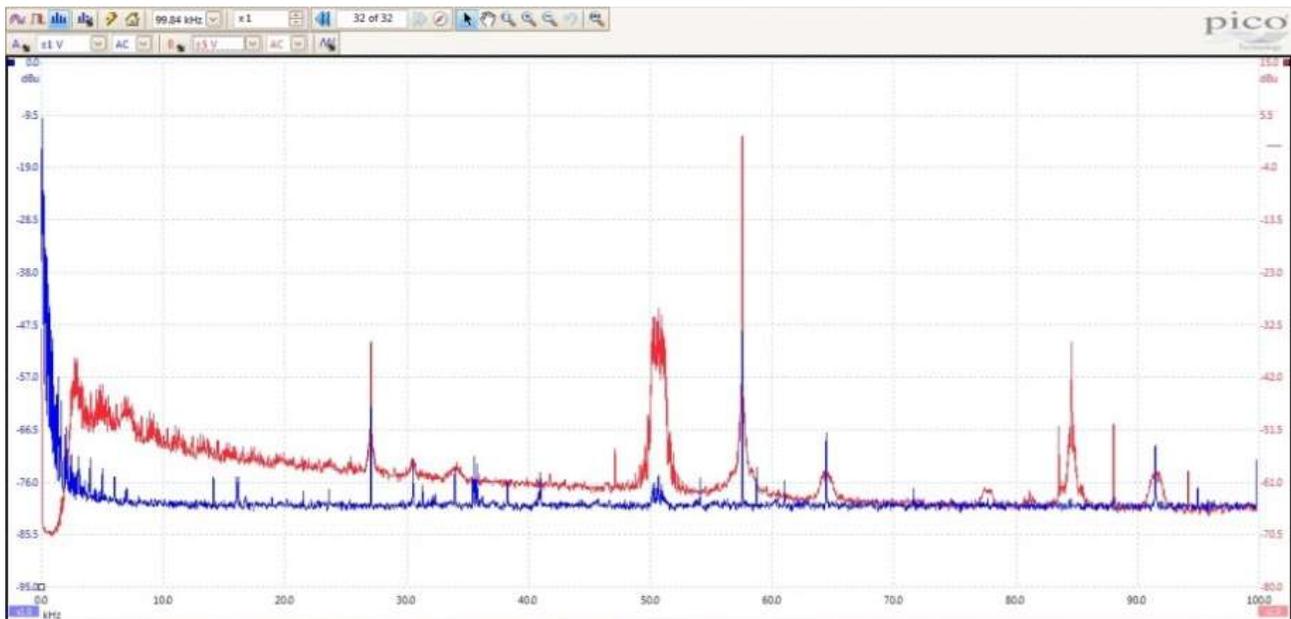
Figure 17 Baseline, inverters off and 21 Stetzer filters installed in the house and 19 filters at the inverters

The baseline spectrum, figure 17, shows harmonics associated with the grid, devices running in the house, and reactive current from the Stetzer filters (seen as harmonic peaks below 10 KHz). When the inverters are running, the EMI harmonics increase significantly, figure 18. The level of EMI with 21 Stetzer filters in the home and another 19 at the inverters appears to be higher than with no Stetzer filters, figure 19. (Note: EMI dirty electricity as indicated by the Stetzer meter decreased when the filters were installed. However, the waveforms and spectrums show an increase in the EMI harmonics with these filters.) The spectrum is similar to the baseline and the SV EMI is gone with the DNA line filters, figure 20.

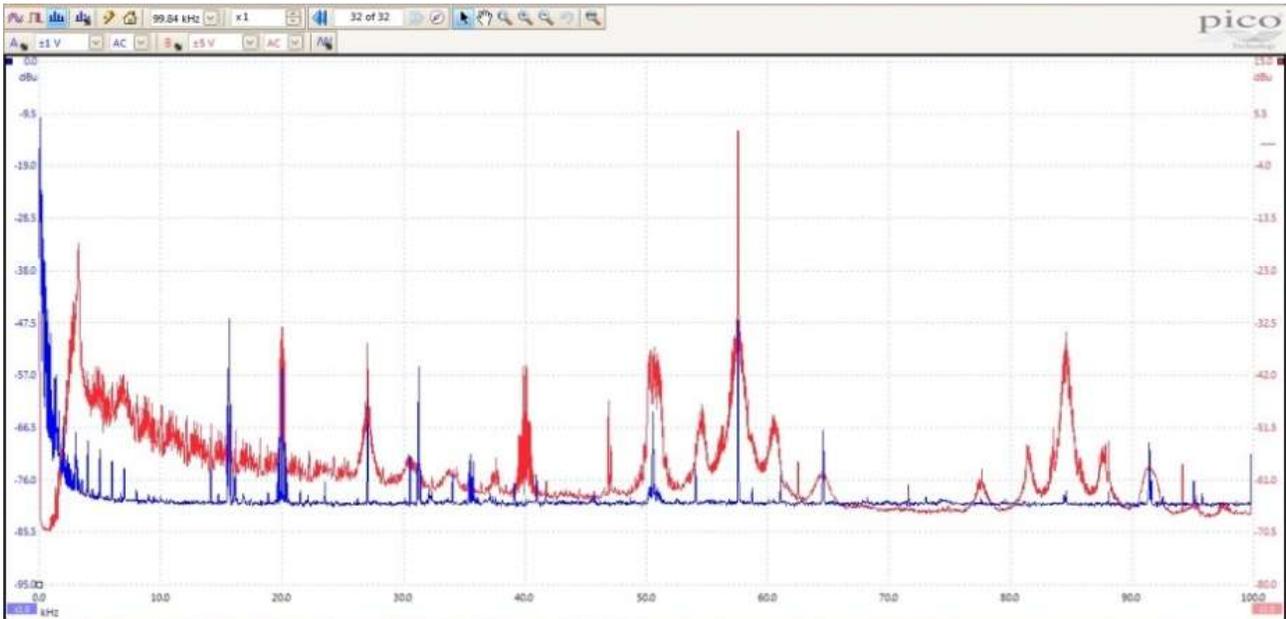
Figure 18 Inverters on with all Stetzer filters installed

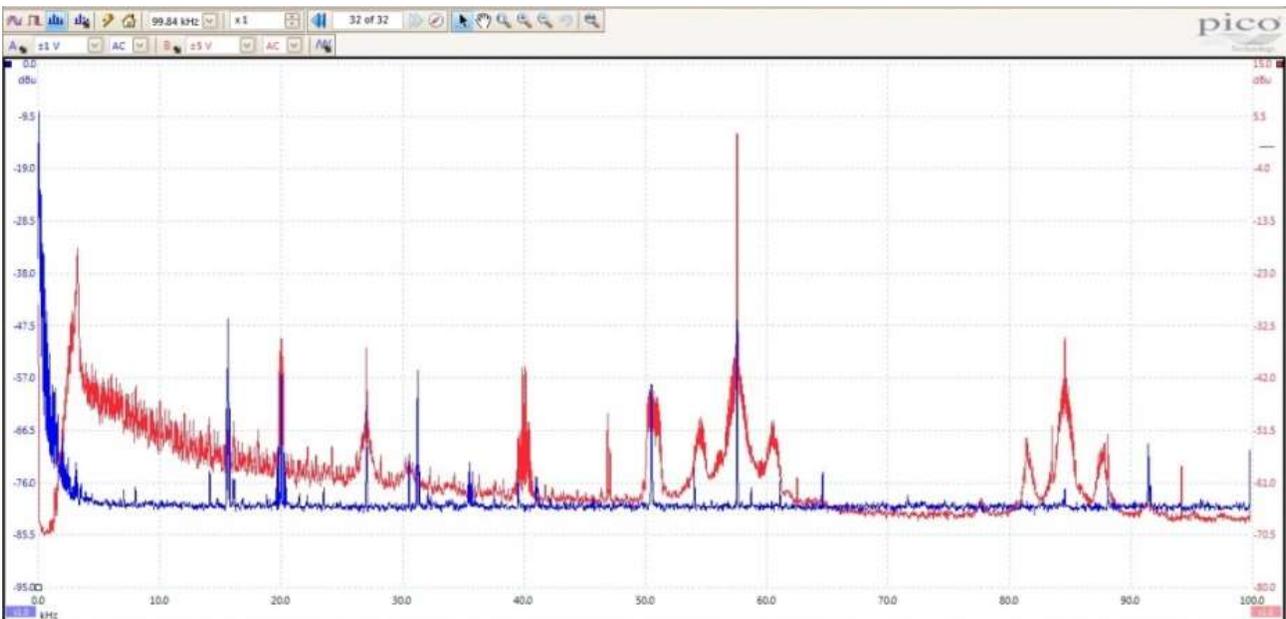
Figure 19 Inverter on, all Stetzer filters removed

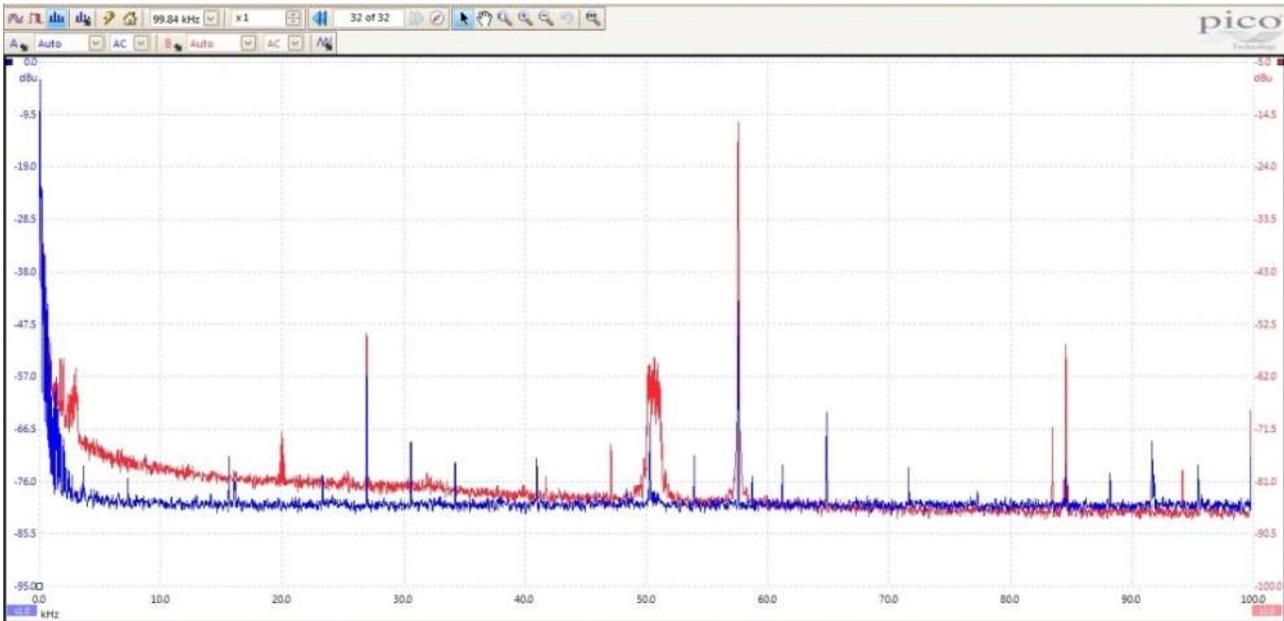
Figure 20 One inverter on with DNA line filter (Blue axis magnetic field is the same as spectrums above and the red axis electric field is 20 dB less than the three spectrums above)

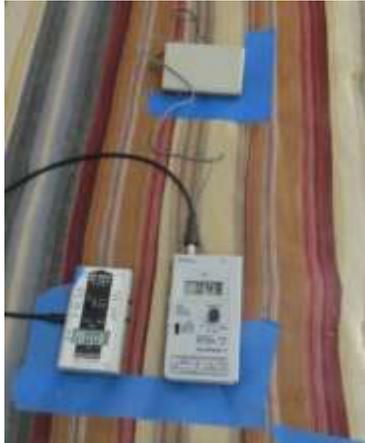
Figure 21 Instruments on 2<sup>nd</sup> story bed.

**5.3 Broadband EMR measurements** in the band >2KHz were recorded at a 2<sup>nd</sup> story bed with the inverters running, with and without Stetzer filters in place, and with one inverter running with DNA line filter in place. EMR is the magnetic (B) field and electric (E) field measured on the bed, with instrument setup shown in figures 16 & 21, and summarized in the table below (see table 1). The B Field is a reflection of the current in the house wiring. The E Field is a reflection of voltage EMI in the house wiring.

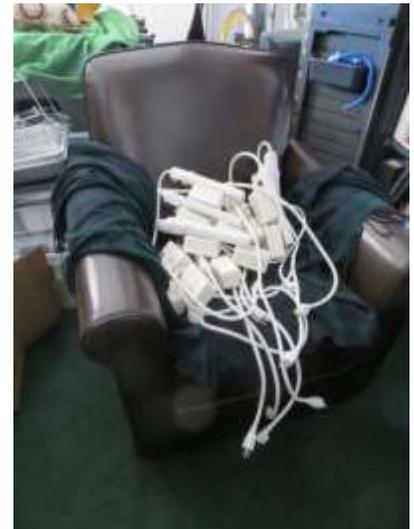
Figure 23 Removed parallel filters.

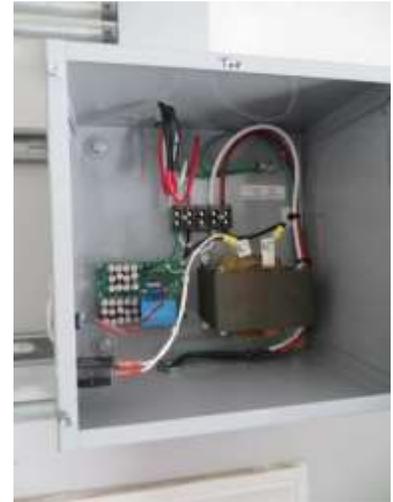
Figure 24 DNA Line Filter.

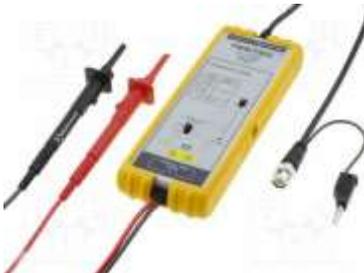
- Testec TT-SI 9002 Active Differential Probe

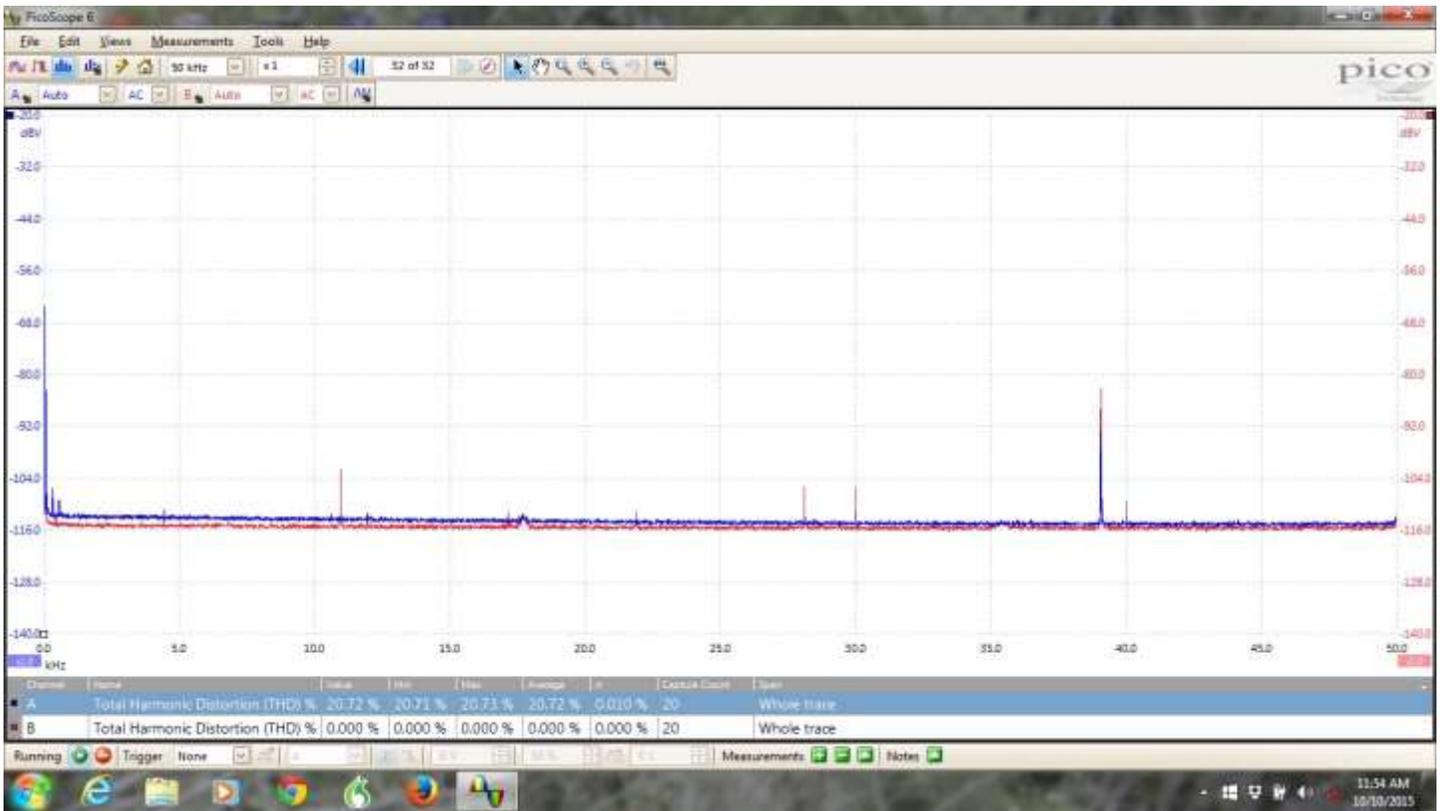
Instrument noise in measurement system, sensors off, is illustrated in the following screen.
